# Manhole Inspection Summary

Manhole # S69M\_\_017MH

Insp Date: **2/4/08 1:37 PM**

**Location** Address: **Bushey St.**

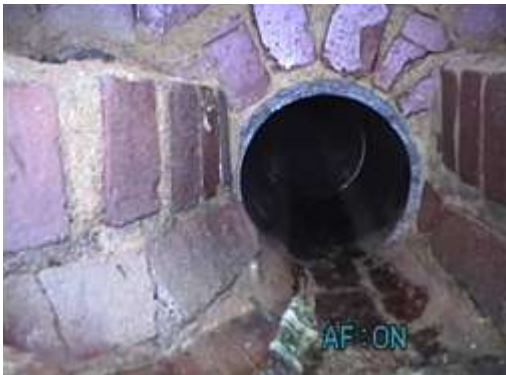
Defect 1

cracks in mortar around pipe. 1:00-2:00  
outgoing 12 o'clock

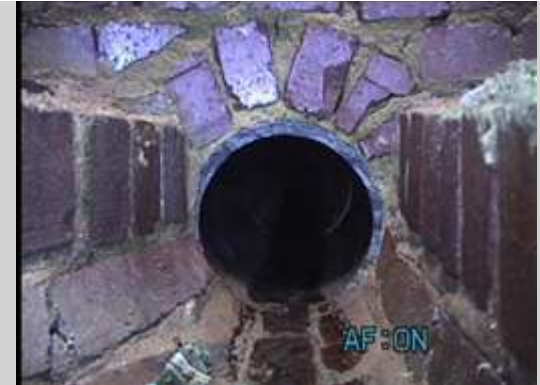
12 O'Clock Outflow

8 in. Circular Gravity Sewer  
Pipe Out @ 12 O'Clock

Pipe Height: **8.4** (in.) Rod and Bar (Angled)  
Pipe Material: **Clay** ☐ Pipe Lined  
Invert Depth: **7.67** (ft.) Flow Characteristics: **Slow**  
Deposits: ☒ None ☐ Mud ☐ ~~Gravy~~ ☐ Debris ☐ Grease  
Silt Depth: (in.) Deposits Extent:  
Infiltration: **None** Pipe Seal Cond: **Cracked**

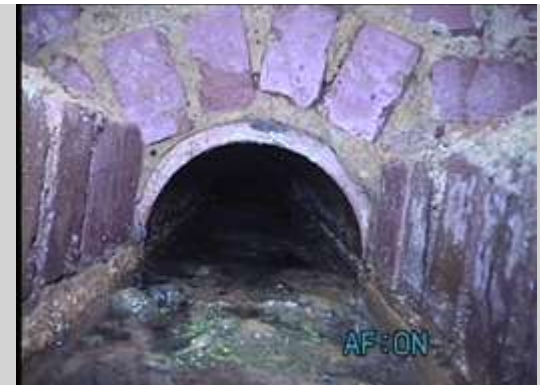
6 O'Clock Inflow

8 in. Circular Gravity Sewer  
Pipe In @ 6 O'Clock

Pipe Height: **8.4** (in.) Rod and Bar (Angled)  
Pipe Material: **Clay** ☐ Pipe Lined  
Invert Depth: **7.63** (ft.) Flow Characteristics: **Slow**  
Deposits: ☐ None ☐ Mud ☒ ~~Gravy~~ ☐ Debris ☐ Grease  
Silt Depth: **2** (in.) Deposits Extent: **Heavy**  
Infiltration: **None** Pipe Seal Cond: **Sound**

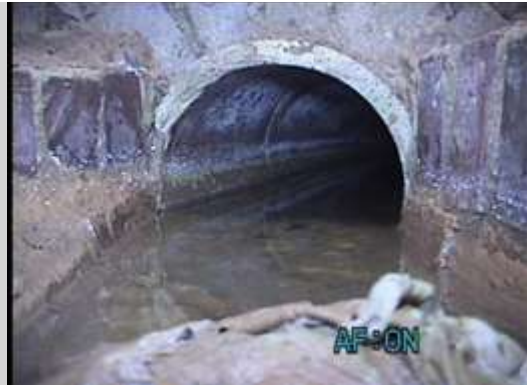
9 O'Clock Inflow

Deposits: ☐ None ☐ Mud ☒ **Sludge** ☐ Debris ☐ Grease

Silt Depth: **1** (in.) Deposits Extent: **Medium**
